**Flood Control Project Maintenance
Levee Inspections**

Maintenance Issue Types Only, Levee Inspection Report By Mile - Fall 2019

Reclamation District No. 2089 Stark

Waterway	Bank	Unit Miles	Inspection Start/End	Inspector
Unit No. 01 Old River	Right	1.51	11/20/2019 11/20/2019	Alberto De Leon

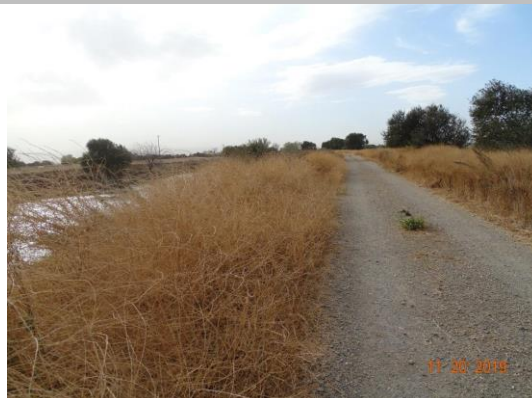
Photo 1 of 2 : FA_2019_RD2089_316_16_20191121_00054.jpg

View of vegetation on waterside slope. Fall 2019

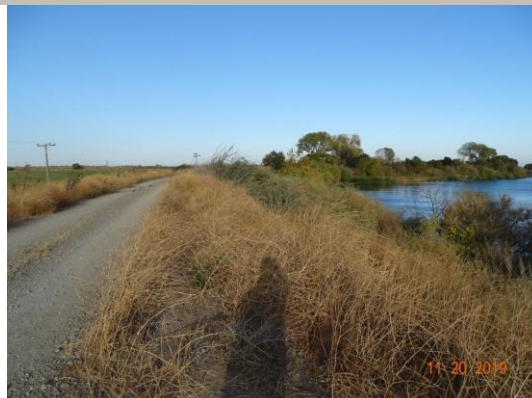
Photo 2 of 2 : FA_2019_RD2089_316_16_20191121_00062.jpg

LM Start	0.03	Rating **	U	Issue No.	16 (cont)
LM End	1.52	Issue Type +	Ma	Location *	WS

View of vegetation on waterside slope. Fall 2019

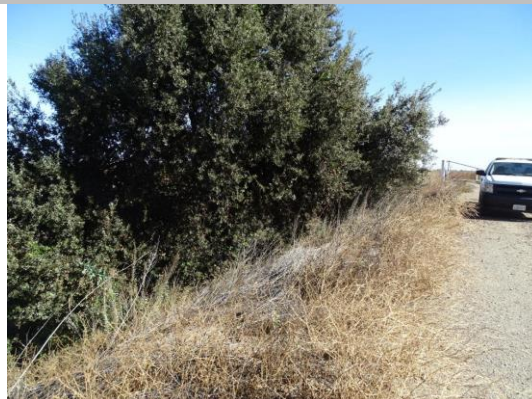
Photo 1 of 1 : FA_2019_RD2089_316_18_20190830_00016.jpg

LM Start	0.03	Rating **	U	Issue No.	18
LM End	0.03	Issue Type +	Ma	Location *	LS
Category	Earthen Levee			GPS Latitude/Longitude	
				Start	End
Item	Trim / Thin Trees			37.811518 °	37.811518 °
				-121.385430 °	-121.385430 °
DWR ID	DWR_RD2089_01_f_2018_18				
Comment Code					
T2 : Thin trees to allow visibility of the ground and room to flood fight.					
Inspector Comment

Looking west at untrimmed trees on landward slope. (Fall 2018)

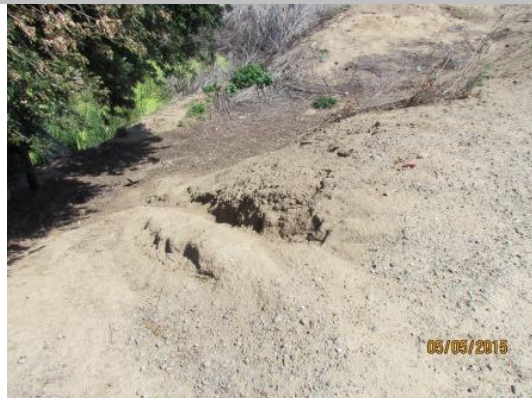
Photo 1 of 2 : FA_2019_RD2089_316_1_20190830_00001.jpg

View of the stairs eroding into the landside levee slope.

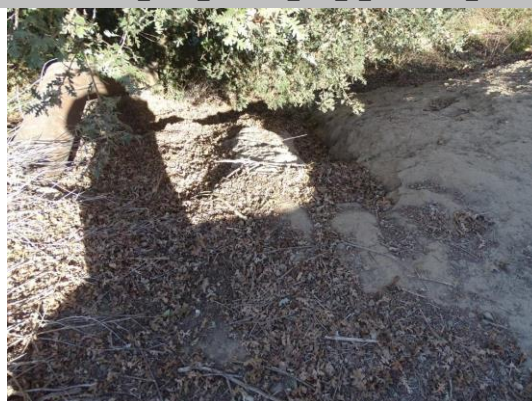
Photo 2 of 2 : FA_2019_RD2089_316_1_20190830_00002.jpg

LM Start	0.03	Rating **	M	Issue No.	1 (cont)
LM End	0.03	Issue Type +	Ma	Location *	LS

View of the stairs eroding into the landside levee slope. (Fall 2018)

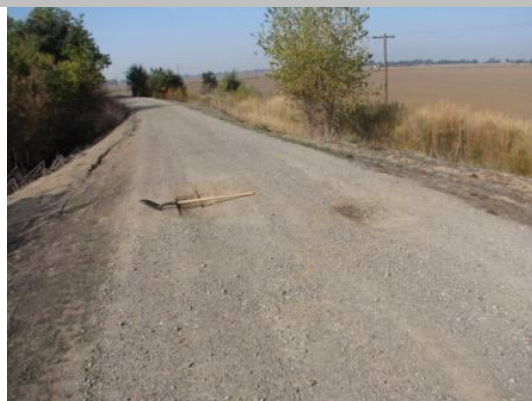
Photo 1 of 1 : FA_2019_RD2089_316_14_20190830_00013.jpg

11/10/2011 Depressions in crown.

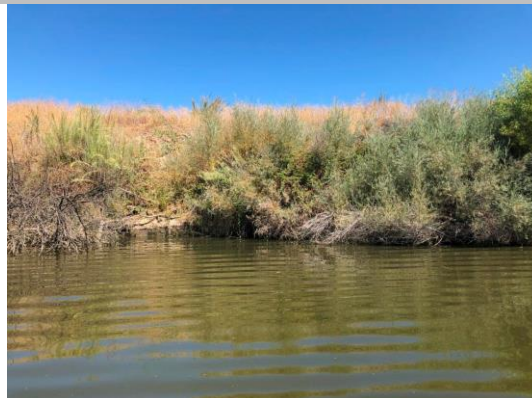
Photo 1 of 2 : SJR2019_RD2089U01RM29.61_6.jpg

Site ID: RD2089U01RM29.61
 08/14/2019: No significant change observed.
 09/13/2017: No significant change observed.
 07/25/2016: No significant change observed.
 06/25/2015: No significant change observed.
 07/02/2014: No significant change observed.
 08/13/2013: No significant change observed.
 08/07/2012: The site has been visited by boat survey. No significant change observed.
 08/23/2011: The 5-foot vertical scarp shows no significant change from the last year inspection. No new erosion activities observed. Dense white willow trees on site.
 09/07/2010: It was difficult to view the erosion due to the thick Willow thickets and other vegetation at the water line. At the time of the inspection, there were no signs of repair on site. As noted during the last survey, there is a 5-foot vertical scarp along the lower slope that may be subjected to high flow velocities.
 08/05/2010: Recommended for repair, per CLRO; "Erosion of this site may be subjective to rapid rates of erosion."

09/28/2009: No major change observed; 5-foot vertical scarp is immediately downstream of where berm has tapered; site is recommended as local maintenance issue, per CLRO CES Evaluation 2008 Report; Site # is the same as RM29.6, LM0.60; previously rated "U".
 11/05/2008: No change observed; rodent holes on lower slope; wide levee crown.

Front view of the site.

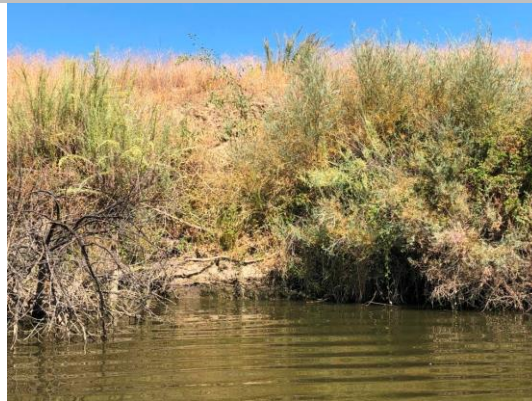
Photo 2 of 2 : SJR2019_RD2089U01RM29.61_5.jpg

Front view of the site. Note the very dense white willow thickets on site.

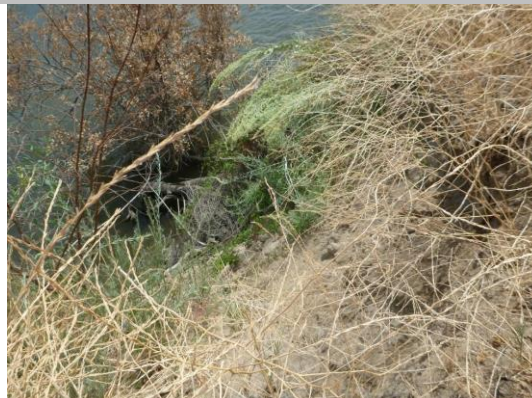
Photo 3 of 3 : LEVAL_FA_2019_512_4464.jpg

LM Start	0.67	Rating **	A/W	Issue No.	20 (cont)
LM End	0.68	Issue Type +	Ma	Location *	
Category	Supplemental			GPS Latitude/Longitude	
				Start	End
Item	2017 Storm Damage			37.809700 °	37.809700 °
				-121.396300 °	-121.396400 °
DWR ID	LMA-418				
Comment Code					
Inspector Comment					
Levee Evaluation Comments					
Description:Slope protection repairs are needed along the waterside slope due to erosion and riprap displacement from high water. Based upon levee inspections, it was determined the waterside levee slope is eroding, deteriorating, and degrading. The eroded levee sections need to be restored back to design standards to prevent further deterioration and damage.					
Site ID No:512					
Site Designation:LMA-418					
Repair Type: Erosion					
Rating:Serious					
Field Date:8/14/2017					
Notes: deep erosion more than half way up slope.

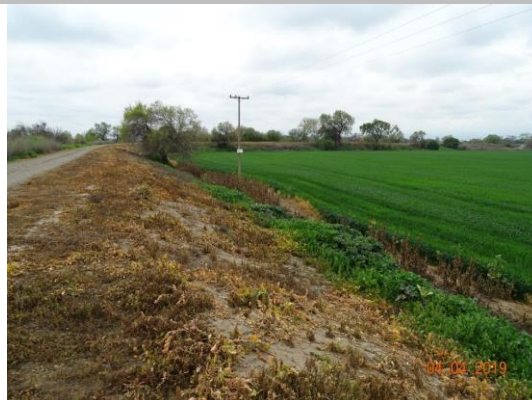
Photo 1 of 1 : FA_2019_RD2089_316_27_20190830_00025.jpg

LM Start	0.83	Rating **	U	Issue No.	27
LM End	1.51	Issue Type +	Ma	Location *	LS
Category	Earthen Levee			GPS Latitude/Longitude	
				Start	End
Item	Vegetation			37.807991 °	37.806638 °
				-121.397847 °	-121.407833 °
DWR ID	DWR_RD2089_01_s_2019_27				
Comment Code					
V2 : Remove the wild growth other than native grasses from the levee slopes.					
Inspector Comment					
Vegetation on landside slope needs to be maintained to allow access and visibility.

View of vegetation on landside slope. (spring 2019)

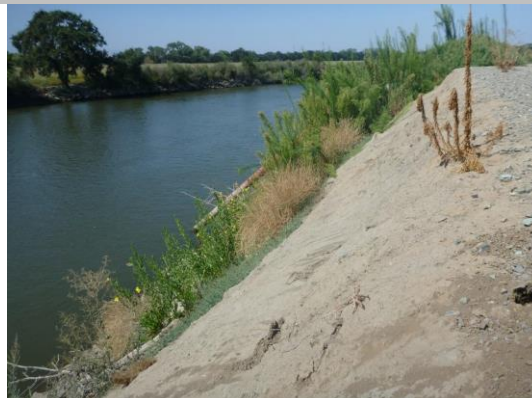
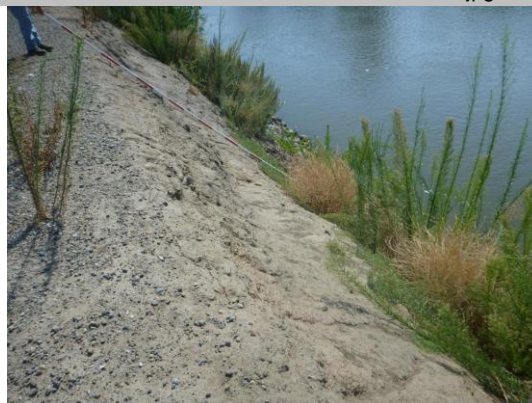
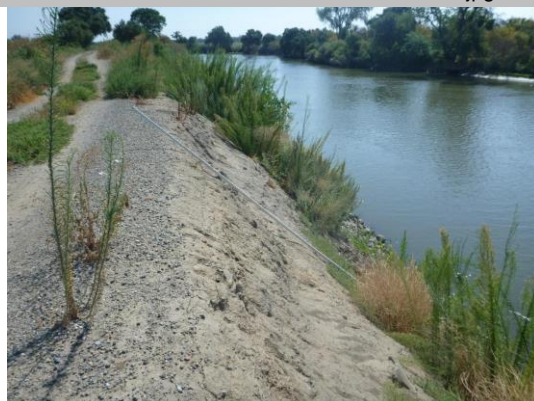
LM Start	1.16	Rating **	A/W	Issue No.	30
LM End	1.18	Issue Type +	Ma	Location *	WS
Category	Supplemental			GPS Latitude/Longitude	
				Start	End
Item	2017 Storm Damage			37.805600 °	37.805600 °
				-121.401700 °	-121.401900 °
DWR ID	LMA-417				
Comment Code					
Inspector Comment					
Levee Evaluation Comments					
Description:Slope protection repairs are needed along the waterside slope due to erosion and riprap displacement from high water. Based upon levee inspections, it was determined the waterside levee slope is eroding, deteriorating, and degrading. The eroded levee sections need to be restored back to design standards to prevent further deterioration and damage.					
Site ID No:511					
Site Designation:LMA-417					
Repair Type: Erosion					
Rating:Critical					
Field Date:8/16/2017					
Notes: Narrow levee with over steep slope

LM Start	1.16	Rating **	A/W	Issue No.	30 (cont)
LM End	1.18	Issue Type +	Ma	Location *	WS
Category	Supplemental			GPS Latitude/Longitude	
				Start	End
Item	2017 Storm Damage			37.805600 °	37.805600 °
				-121.401700 °	-121.401900 °
DWR ID	LMA-417				
Comment Code					
Inspector Comment					
Levee Evaluation Comments					
Description:Slope protection repairs are needed along the waterside slope due to erosion and riprap displacement from high water. Based upon levee inspections, it was determined the waterside levee slope is eroding, deteriorating, and degrading. The eroded levee sections need to be restored back to design standards to prevent further deterioration and damage.					
Site ID No:511					
Site Designation:LMA-417					
Repair Type: Erosion					
Rating:Critical					
Field Date:8/16/2017					
Notes: Narrow levee with over steep slope

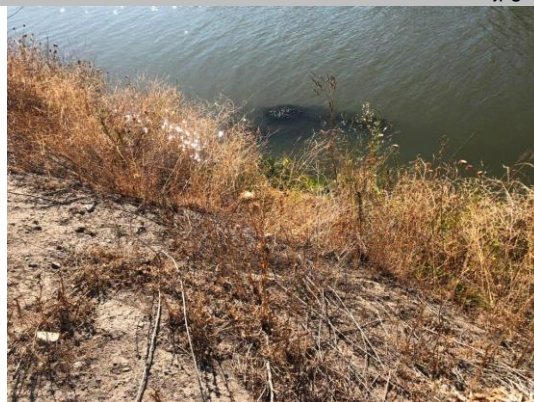
Photo 1 of 2 : SJR2019_RD2089U01RM29.10_1.jpg

LM Start	1.17	Rating **	A/W	Issue No.	3	
LM End	1.17	Issue Type +	Ma	Location *		
Category	Supplemental			GPS Latitude/Longitude		
				Start	End	
Item	DWR Erosion Survey			37.805523 °	37.805523 °	
				-121.401718 °	-121.401718 °	
DWR ID	RD2089U01RM29.1					
Comment Code						
Inspector Comment						
Site ID: RD2089U01RM29.1						
09/26/2019: No significant change observed.						
09/13/2017: The erosion is at the upstream of a small tree, inside of a slight river bend.

Looking at the erosion from levee top.

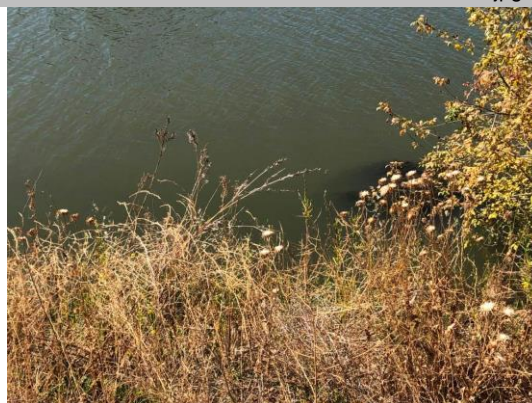
Photo 2 of 2 : SJR2019_RD2089U01RM29.10_4.jpg

LM Start	1.17	Rating **	A/W	Issue No.	3 (cont)	
LM End	1.17	Issue Type +	Ma	Location *		
Category	Supplemental			GPS Latitude/Longitude		
				Start	End	
Item	DWR Erosion Survey			37.805523 °	37.805523 °	
				-121.401718 °	-121.401718 °	
DWR ID	RD2089U01RM29.1					
Comment Code						
Inspector Comment						
Site ID: RD2089U01RM29.1						
09/26/2019: No significant change observed.						
09/13/2017: The erosion is at the upstream of a small tree, inside of a slight river bend.

Close-up view of the erosion. Note the trees next to the erosion site.

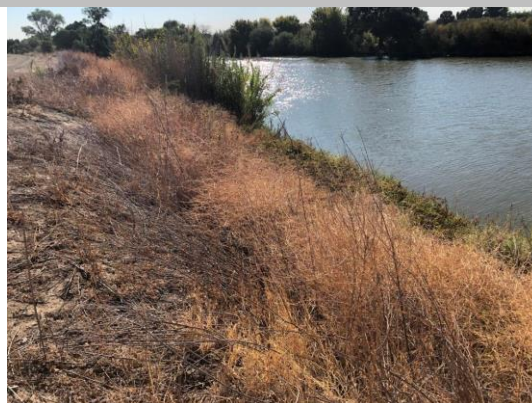
Photo 1 of 2 : SJR2019_RD2089U01RM29.04_2.JPG

LM Start	1.22	Rating **	M	Issue No.	2
LM End	1.23	Issue Type +	Ma	Location *	
Category	Supplemental			GPS Latitude/Longitude	
				Start	End
Item	DWR Erosion Survey			37.805580°	37.805580°
				-121.403010°	-121.403010°
DWR ID	RD2089U01RM29.04				
Comment Code					
Inspector Comment					
Site ID: RD2089U01RM29.04					
09/26/2019: No significant change observed.					
09/13/2017: No significant change observed. More vegetation observed at the site.					
09/16/2016: The river was not navigable near the site due to the dense water grass, so the site was visited by land survey. No significant change observed.					
06/25/2015: No significant change observed.					
07/02/2014: No significant change observed.					
08/13/2013: The erosion is around a tree at the levee toe. Dense vegetation is visible.

Looking at the erosion from levee top.

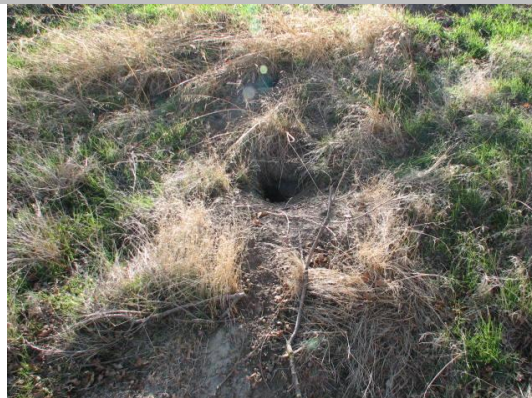
Photo 1 of 1 : FA_2019_RD2089_316_47_20190830_00036.jpg

View of active rodent burrow on landside slope. 11/10/2011

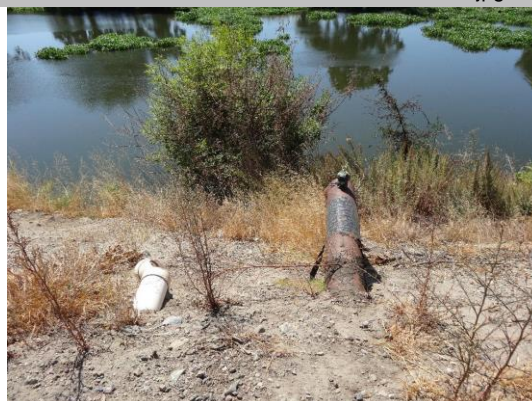
Photo 1 of 3 : UCIP_FA_2019_21585_36624.jpg

LM Start	1.41	Rating **	M	Issue No.	53	
LM End	1.41	Issue Type +	Ma	Location *		
Category	Supplemental			GPS Latitude/Longitude		
				Start	End	
Item	DRAFT DWR UCIP LMA Responsibility			37.806323°	37.806323°	
				-121.406155°	-121.406155°	
DWR ID	23045					
Comment Code						
Inspector Comment						
DS_ID:23045 FS_ID:21585 EP_NO: N/A Repair Type: Non-Urgent Crossing Status: Found UCIP Comments: - siphon breaker needs repair. FIELD_STRUCT_DESC: 10-inch steel drainage discharge pipe through the levee, 2.4 feet below the crown. Pump in a drainage ditch on the landside (LS). Siphon breaker on the waterside (WS) shoulder. [Additional Reference(s): DWR Levee Log, 1991]. FS Date: 9/12/2013

WS view: exposed steel pipe on levee slope. A pvc pipe on left.

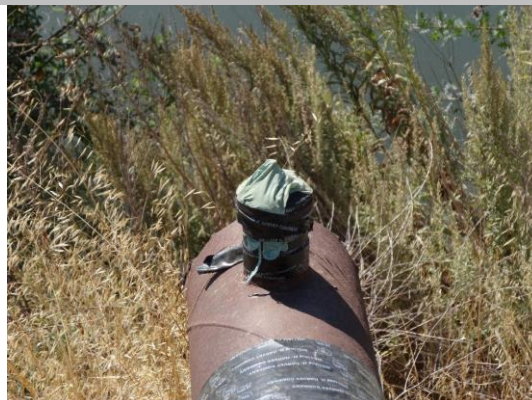
Photo 2 of 3 : UCIP_FA_2019_21585_36623.jpg

WS view: exposed steel pipe with siphon breaker. Looks siphon breaker needs repair.

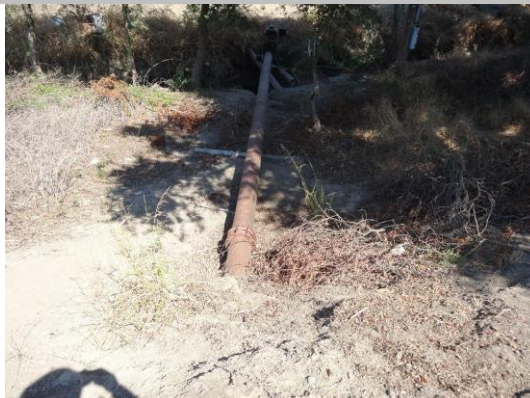
Photo 3 of 3 : UCIP_FA_2019_21585_36622.jpg

LM Start	1.41	Rating **	M	Issue No.	53 (cont)	
LM End	1.41	Issue Type +	Ma	Location *		
Category	Supplemental			GPS Latitude/Longitude		
				Start	End	
Item	DRAFT DWR UCIP LMA Responsibility			37.806323°	37.806323°	
				-121.406155°	-121.406155°	
DWR ID	23045					
Comment Code						
Inspector Comment						
DS_ID:23045 FS_ID:21585 EP_NO: N/A Repair Type: Non-Urgent Crossing Status: Found UCIP Comments: - siphon breaker needs repair. FIELD_STRUCT_DESC: 10-inch steel drainage discharge pipe through the levee, 2.4 feet below the crown. Pump in a drainage ditch on the landside (LS). Siphon breaker on the waterside (WS) shoulder. [Additional Reference(s): DWR Levee Log, 1991]. FS Date: 9/12/2013

LS view: exposed steel pipe on levee slope.

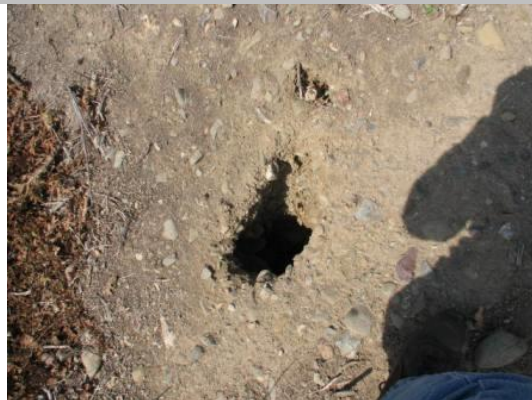
Photo 1 of 1 : FA_2019_RD2089_316_49_20190830_00037.jpg

View of deep burrow on waterside. 11/10/2011

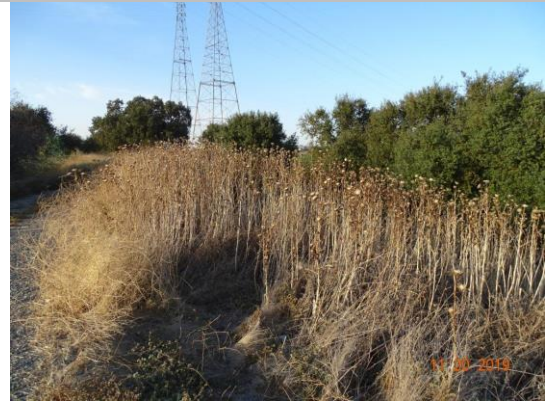
Photo 1 of 1 : FA_2019_RD2089_317_60_20191121_00071.jpg

View of vegetation on landside slope. Fall 2019

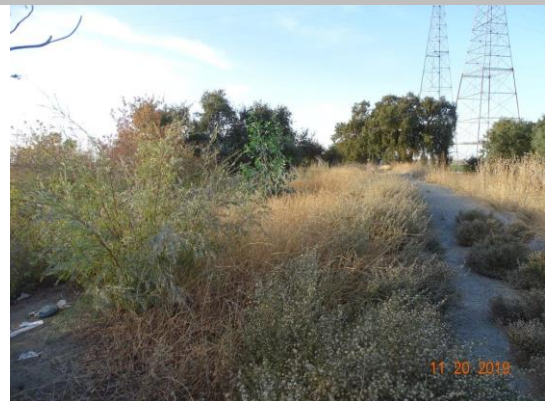
Photo 1 of 2 : FA_2019_RD2089_317_58_20191121_00072.jpg

View of vegetation on waterside slope. Fall 2019

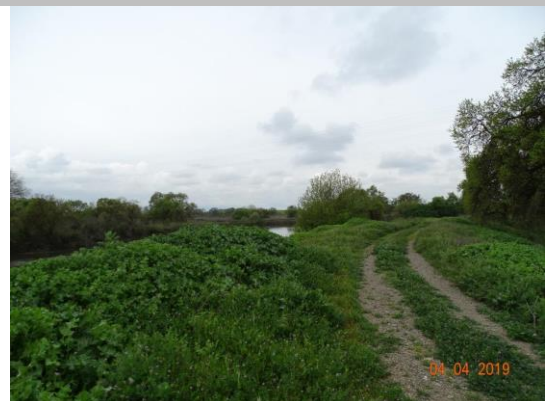
Photo 2 of 2 : FA_2019_RD2089_317_58_20190830_00067.jpg

LM Start	0.00	Rating **	U	Issue No.	58 (cont)
LM End	1.34	Issue Type +	Ma	Location *	WS

Typical view of vegetation on waterside slope. (Spring 2019)

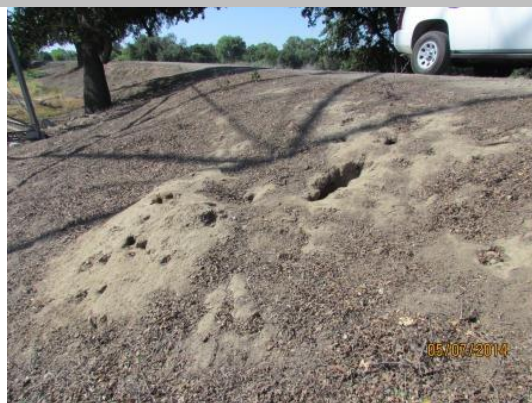
Photo 1 of 1 : FA_2019_RD2089_317_48_20190830_00051.jpg

View of the rodent burrow on the landside levee slope.

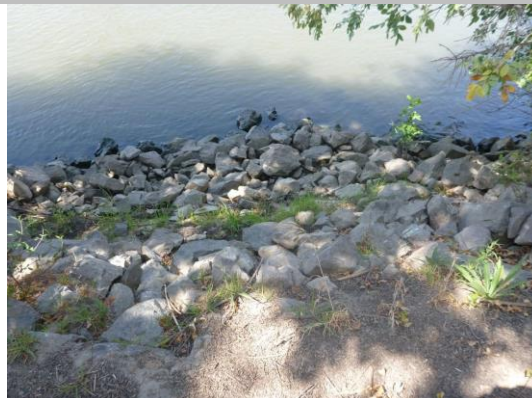
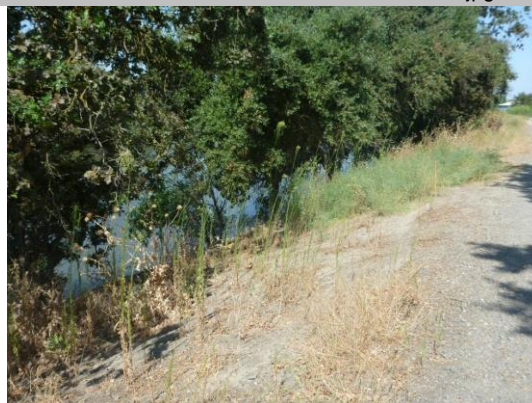
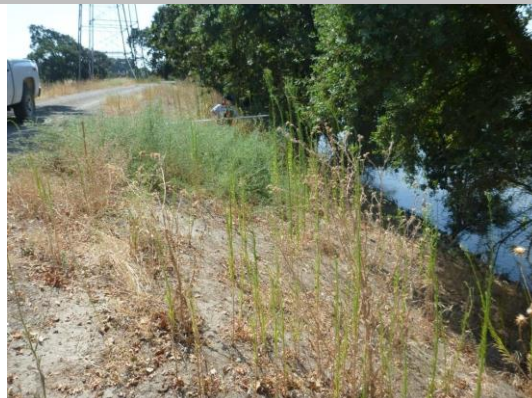
LM Start	0.20	Rating **	M	Issue No.	46
LM End	0.21	Issue Type +	Ma	Location *	WS
Category	Supplemental			GPS Latitude/Longitude	
				Start	End
Item	2017 Storm Damage			37.809100 °	37.809200 °
				-121.409800 °	-121.409900 °
DWR ID	LMA-415				
Comment Code					
Inspector Comment					
Levee Evaluation Comments					
Description:Slope protection repairs are needed along the waterside slope due to erosion and riprap displacement from high water. Based upon levee inspections, it was determined the waterside levee slope is eroding, deteriorating, and degrading. The eroded levee sections need to be restored back to design standards to prevent further deterioration and damage.					
Site ID No:509					
Site Designation:LMA-415					
Repair Type: Erosion					
Rating:Area of Concern					
Field Date:8/16/2017					
Notes: Displaced riprap at toe.

LM Start	0.20	Rating **	M	Issue No.	46 (cont)	
LM End	0.21	Issue Type +	Ma	Location *	WS	
Category	Supplemental			GPS Latitude/Longitude		
				Start	End	
Item	2017 Storm Damage			37.809100 °	37.809200 °	
				-121.409800 °	-121.409900 °	
DWR ID	LMA-415					
Comment Code						
Inspector Comment						
Levee Evaluation Comments						
Description:Slope protection repairs are needed along the waterside slope due to erosion and riprap displacement from high water. Based upon levee inspections, it was determined the waterside levee slope is eroding, deteriorating, and degrading. The eroded levee sections need to be restored back to design standards to prevent further deterioration and damage.						
Site ID No:509						
Site Designation:LMA-415						
Repair Type: Erosion						
Rating:Area of Concern						
Field Date:8/16/2017						
Notes: Displaced riprap at toe.

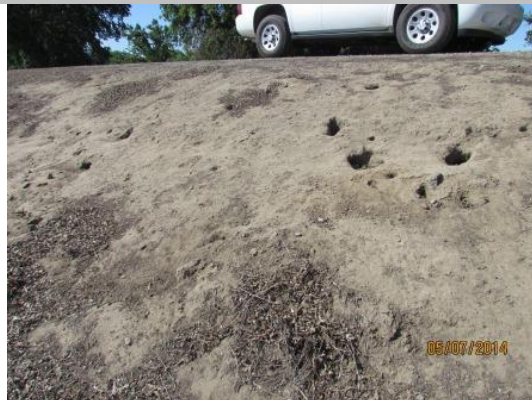
Photo 1 of 1 : FA_2019_RD2089_317_49_20190830_00052.jpg

LM Start	0.21	Rating **	M	Issue No.	49
LM End	0.21	Issue Type +	Ma	Location *	LS
Category	Earthen Levee			GPS Latitude/Longitude	
				Start	End
Item	Animal Control			37.809148 °	37.809148 °
				-121.409897 °	-121.409897 °
DWR ID	DWR_RD2089_02_s_2018_49				
Comment Code					
A3 : No rodents visible, but rodent burrows visible; need to backfill and compact or grout burrows.					
Inspector Comment

View of the multiple rodent burrows on the landside levee hinge and slope.

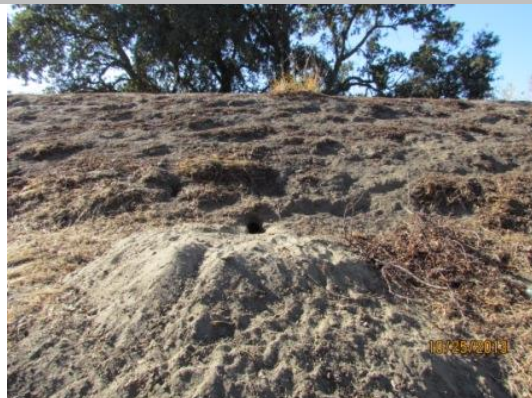
Photo 2 of 3 : FA_2019_RD2089_317_53_20190830_00059.jpg

View of the rodent burrow on the landside levee slope.

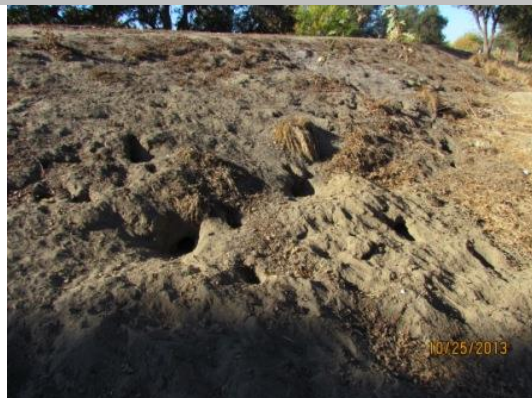
Photo 3 of 3 : FA_2019_RD2089_317_53_20190830_00060.jpg

Another view of the multiple rodent burrows on the landside levee slope.

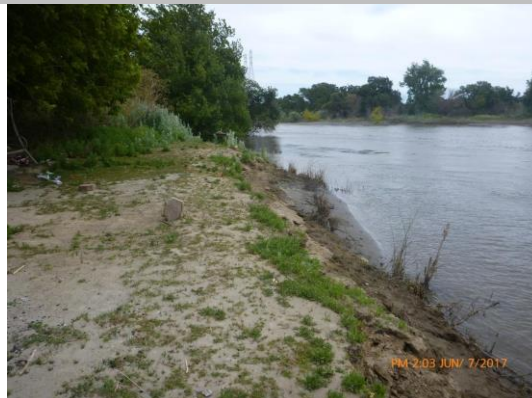
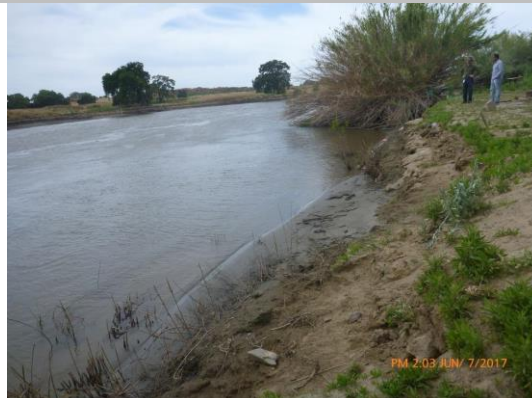
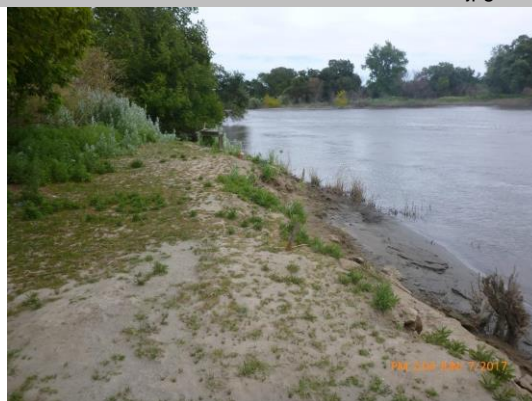
LM Start	0.32	Rating **	A/W	Issue No.	47
LM End	0.57	Issue Type +	Ma	Location *	WS
Category	Supplemental			GPS Latitude/Longitude	
				Start	End
Item	2017 Storm Damage			37.810020 °	37.811810 °
				-121.411550 °	-121.415390 °
DWR ID	335-103				
Comment Code					
Inspector Comment					
Levee Evaluation Comments					
Description:					
Site ID No:109					
Site Designation:335-103					
Repair Type: Erosion					
Rating:Area of Concern					
Field Date:6/7/2017					
Notes: vegetation too dense for evaluation

LM Start	0.32	Rating **	A/W	Issue No.	47 (cont)	
LM End	0.57	Issue Type +	Ma	Location *	WS	
Category	Supplemental			GPS Latitude/Longitude		
				Start		End
Item	2017 Storm Damage			37.810020	°	37.811810
				-121.411550	°	-121.415390
DWR ID	335-103					
Comment Code						
Inspector Comment						
Levee Evaluation Comments						
Description:						
Site ID No:109						
Site Designation:335-103						
Repair Type: Erosion						
Rating:Area of Concern						
Field Date:6/7/2017						
Notes: vegetation too dense for evaluation

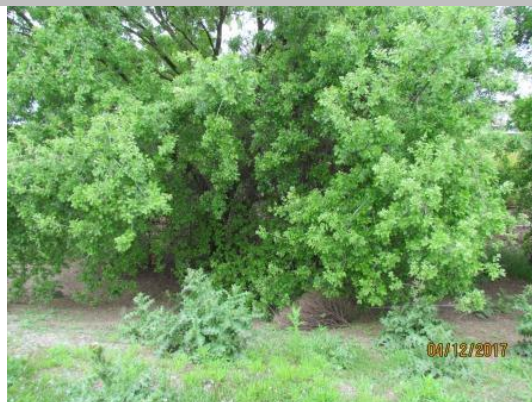
Photo 1 of 1 : FA_2019_RD2089_317_55_20190830_00062.jpg

LM Start	0.34	Rating **	M	Issue No.	55
LM End	0.34	Issue Type +	Ma	Location *	LS
Category	Earthen Levee			GPS Latitude/Longitude	
				Start	End
Item	Trim / Thin Trees			37.810052°	37.810052°
				-121.411966°	-121.411966°
DWR ID	DWR_RD2089_02_s_2017_55				
Comment Code					
T1 : Trim trees to at least five feet above ground level.					
Inspector Comment

View of the overgrown tree on the levee slope.

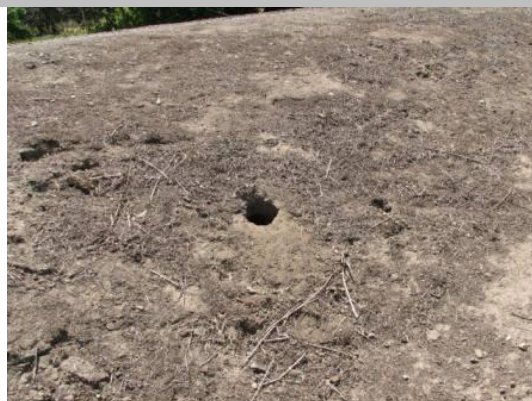
Photo 1 of 1 : FA_2019_RD2089_317_26_20190830_00027.jpg

View of active rodent burrow. 05/24/2011

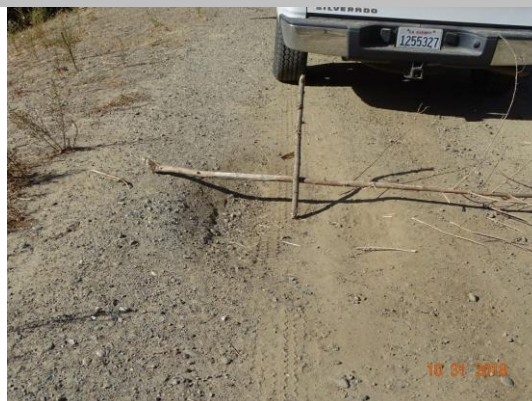
Photo 1 of 1 : FA_2019_RD2089_317_7_20190830_00007.jpg

LM Start	0.39	Rating **	U	Issue No.	7
LM End	0.39	Issue Type +	Ma	Location *	CR
Category	Earthen Levee			GPS Latitude/Longitude	
				Start	End
Item	Crown Surface / Depressions / Rutting			37.810140 °	37.810140 °
				-121.412906 °	-121.412906 °
DWR ID	DWR_RD2089_02_f_2018_7				
Comment Code					
C2 : Repair depressions or ruts in the crown or slope.					
Inspector Comment

View of depression greater than six inches on levee crown. (Fall 2018)

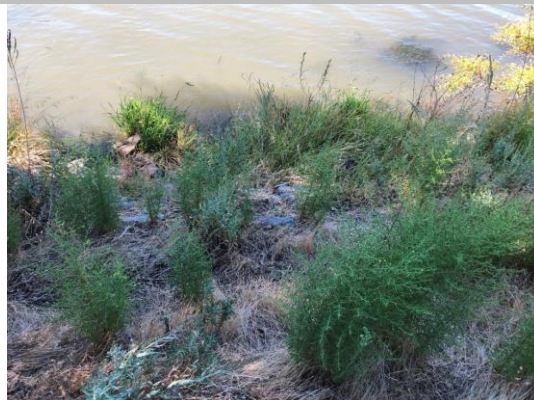
Photo 1 of 3 : SJR2019_RD2089U02RM28.35_1.jpg

Looking at the erosion from levee top.

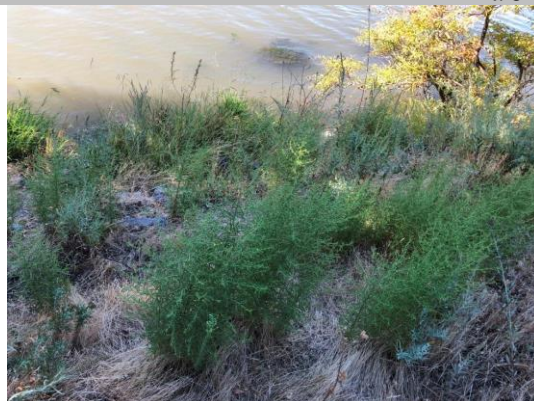
Photo 2 of 3 : SJR2019_RD2089U02RM28.35_4.jpg

Close-up view of the erosion.

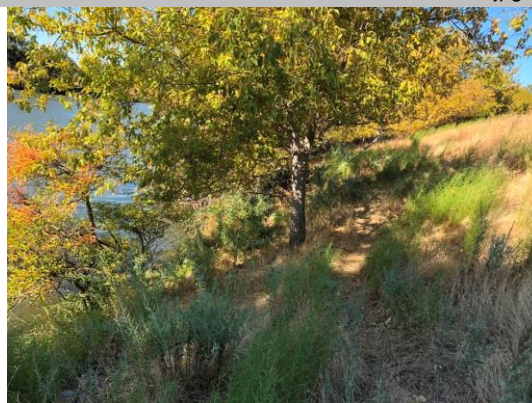
Photo 3 of 3 : SJR2019_RD2089U02RM28.35_5.jpg

Close-up view of the erosion.

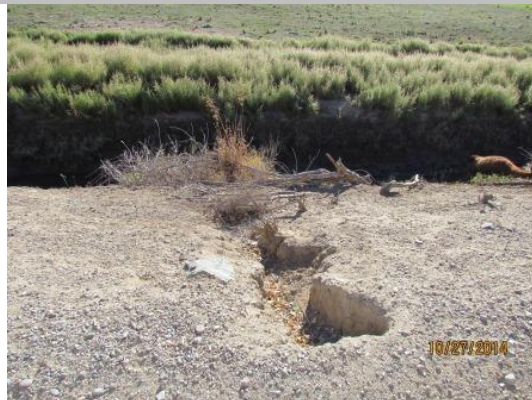
Photo 1 of 1 : FA_2019_RD2089_317_15_20190830_00017.jpg

LM Start	0.76	Rating **	M	Issue No.	15
LM End	0.76	Issue Type +	Ma	Location *	LS
Category	Earthen Levee			GPS Latitude/Longitude	
				Start	End
Item	Erosion / Bank Caving			37.813934°	37.813934°
				-121.414320°	-121.414320°
DWR ID	DWR_RD2089_02_f_2014_15				
Comment Code					
E2 : Schedule repair of erosion site prior to the next inspection.					
Inspector Comment

View of the scour from surface runoff on the landside levee slope.

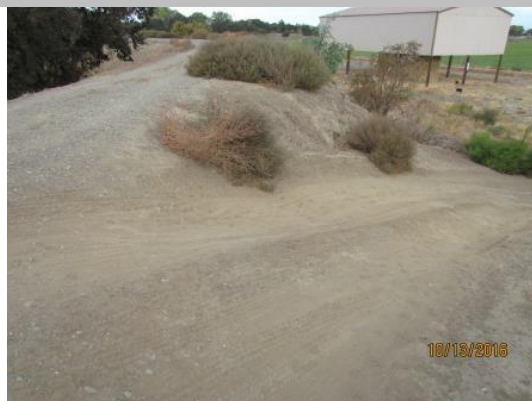
Photo 1 of 1 : FA_2019_RD2089_317_42_20190830_00044.jpg

View of the ramp on the landside levee slope.

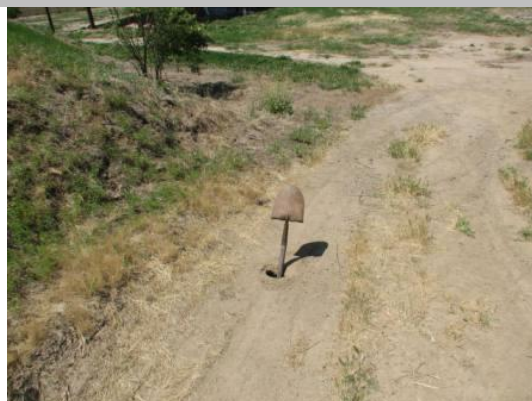
Photo 1 of 3 : FA_2019_RD2089_317_40_20190830_00040.jpg

View of deep vertical burrow in ramp on landside of levee. 05/24/2011

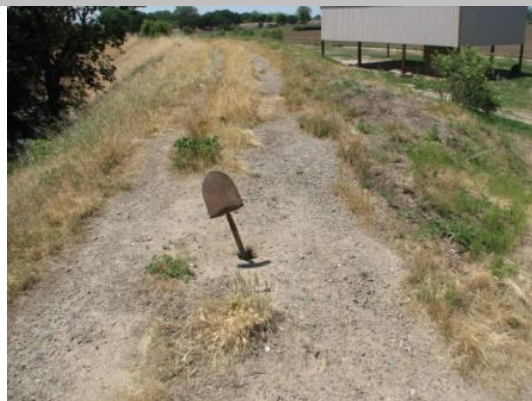
Photo 2 of 3 : FA_2019_RD2089_317_40_20190830_00041.jpg

View of deep vertical burrow in levee crown. 05/24/2011

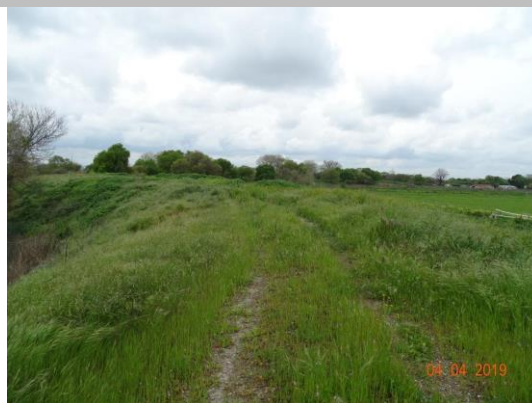
Photo 1 of 1 : FA_2019_RD2089_317_36_20190830_00038.jpg

View of vegetation on levee crown. (Spring 2019)

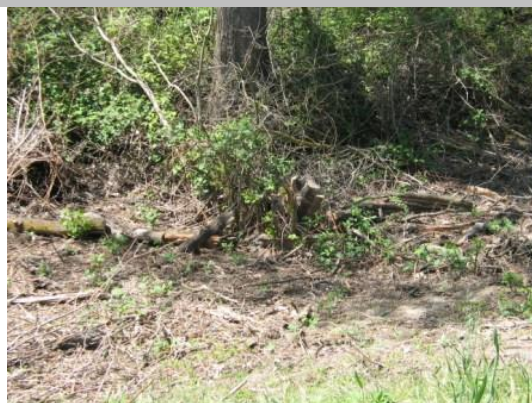
Photo 1 of 1 : FA_2019_RD2089_317_29_20190830_00032.jpg

View of tree stump left after vegetation and tree removal.

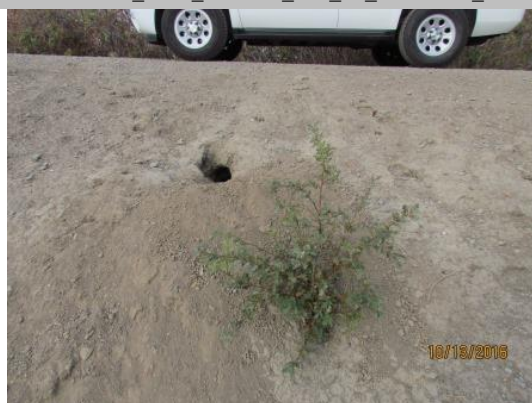
Photo 1 of 1 : FA_2019_RD2089_317_28_20190830_00031.jpg

View of the rodent burrow in the landside levee slope.

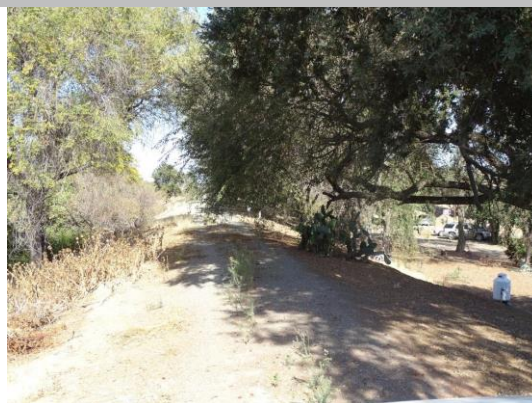
Photo 1 of 1 : FA_2019_RD2089_317_33_20190830_00033.jpg

Looking west at trees overhanging crown of levee. (Fall 2018)

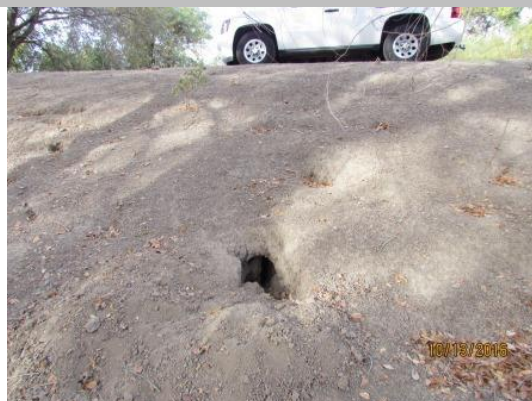
Photo 1 of 1 : FA_2019_RD2089_317_19_20190830_00021.jpg

View of the rodent burrow in the landside levee slope.

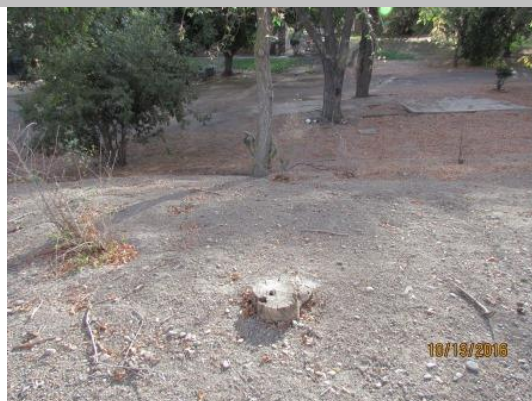
Photo 1 of 1 : FA_2019_RD2089_317_18_20190830_00020.jpg

View of the tree stump from the levee crown.

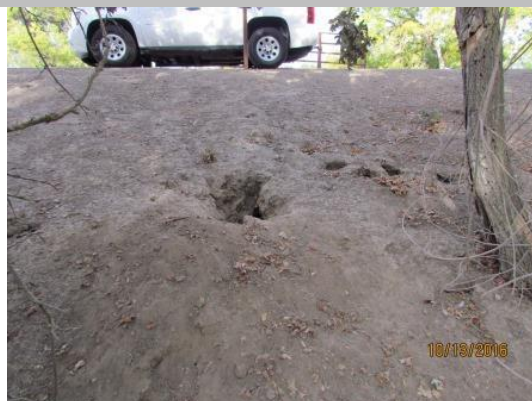
Photo 1 of 1 : FA_2019_RD2089_317_16_20190830_00018.jpg

View of the rodent burrow in the landside levee slope.

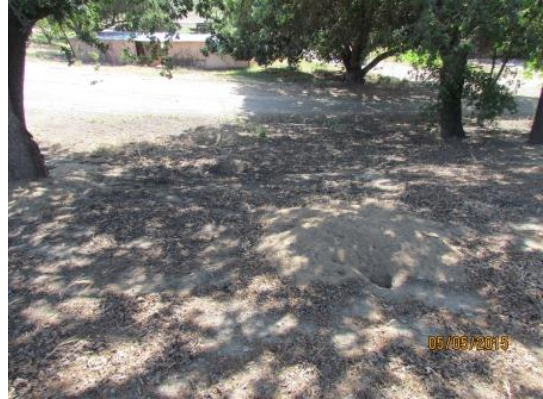
Photo 1 of 1 : FA_2019_RD2089_317_11_20190830_00012.jpg

View of the multiple rodent burrows on the landside levee slope.
